Dam ID: KA-0030  
Kaloko Reservoir

Inspection No: 2016-044  
Date: April 12, 2016

STATE OF HAWAII - DLNR  
DAM SAFETY INSPECTION SHEET

Inspection Type: Visual Dam Safety Inspection

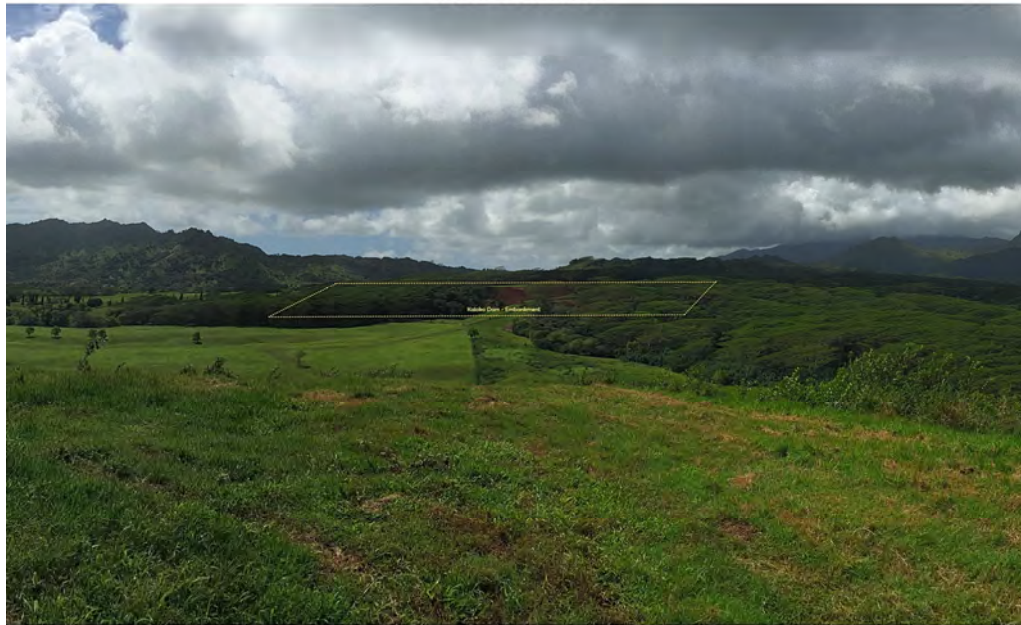
Kaloko (201).JPG

Kalako Reservoir (KA-0030)  
dam from afar

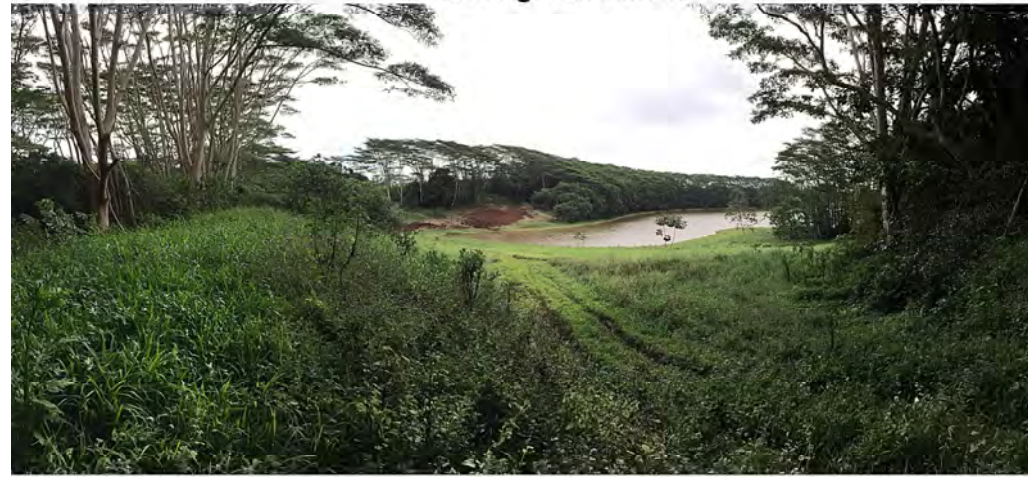
Kaloko (203).JPG

Kalako Reservoir (KA-0030)  
view from right abutment

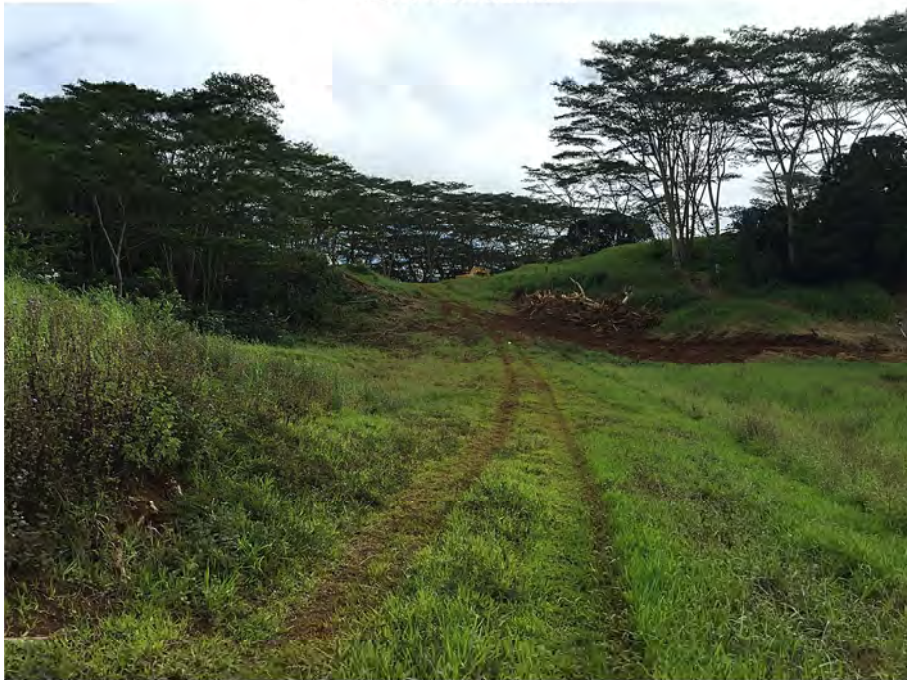
Kaloko (204).JPG

Kalako Reservoir (KA-0030)  
view of left abutment

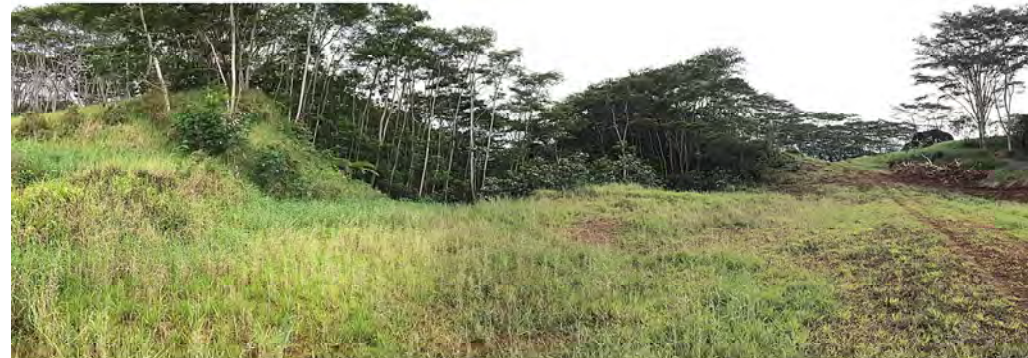
Kaloko (205).JPG

Kalako Reservoir (KA-0030)  
view of breach from reservoir

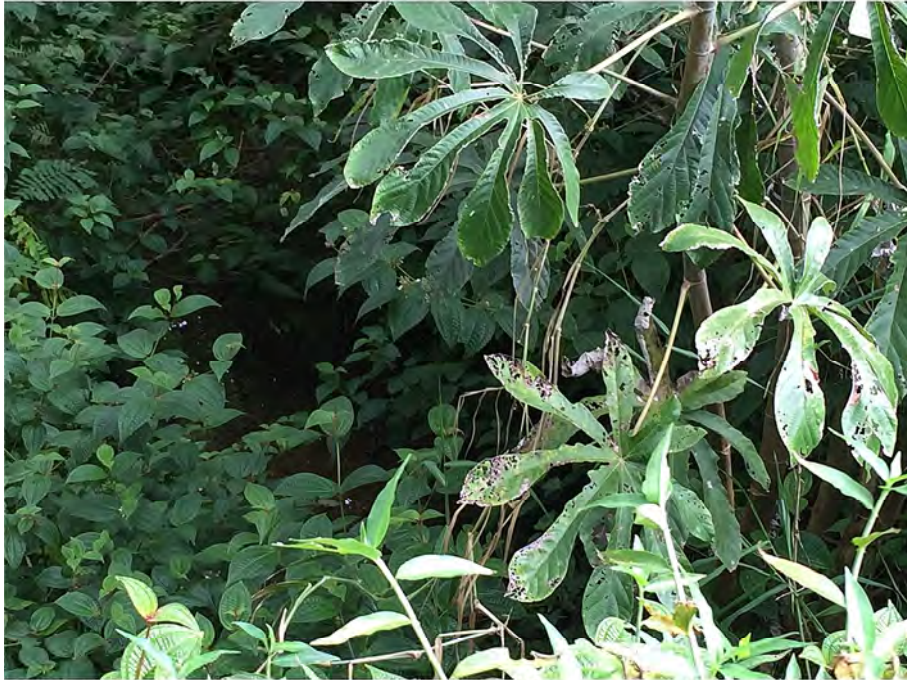
Kaloko (206).JPG

**7. Downstream Slope:**(Typical Slope  $\pm$  2 H : 1 V )Access: ☐ lower roadway along toe ☐ roadway to outlet works ☐ walkway to outlet works ☒ None ObservedSlope Protection: ☒ None ☐ Dumped Rock ☐ Rip Rap ☐ Grouted Rip Rap ☐ ConcreteErosion: ☐ Loose soil w/ little vegetation ☐ Rut (<6") ☒ Gully (>6" deep) ☐ Not Visible ☐ None ObservedDescription: Left side of embankment has been noted to have a large erosion hole(AECOM April 2011)Cracks: ☐ Parallel with crest ☐ Perpendicular to crest ☐ Slide visible ☒ Not Visible ☒ None ObservedDescription: Excessive vegetation limited observations and accessSinkholes: ☐ \_\_\_\_\_ in. Wide x \_\_\_\_\_ in. Long x \_\_\_\_\_ in. Deep ☒ Not Visible ☒ None ObservedDescription: Excessive vegetation limited observations and accessVegetation: ☐ None ☐ Low Ground Cover ☒ Bushes or Tall Grass ☒ Trees # 100+ ☒ <6" ☒ >6" & <20" ☒ >20"Description: Excessive vegetation on left, breach section and right downstream slope (photos 206, 207, 208)Seepage: Seep Spot Number 1☐ Green Vegetation ☐ Wet or Muddy Ground ☒ Ponding Water ☐ Not Visible ☐ None Observed☐ Flowing, Description: Excessive vegetation limited accessWater Clarity: ☐ Clear ☐ Some particles ☐ Muddy ☐ Other: \_\_\_\_\_Description: Ponded water on second (lower) bench, 4/16/14 and 4/12/16 (photos 206, 207)**Findings:**

- ☒ m. Seepage/Ponding water was observed. Monitor and conduct further investigation to locate the source of water and extent of any possible hazardous or developing condition.

Kalako Reservoir (KA-0030)  
ponding water in breach

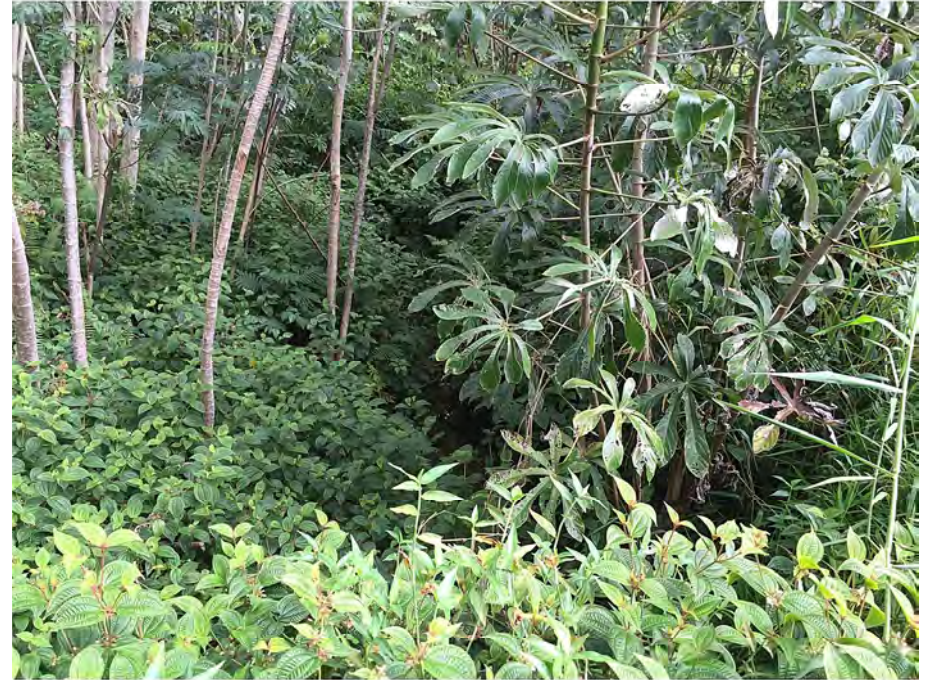
Kaloko (207).JPG

Kalako Reservoir (KA-0030)  
ponding water in breach

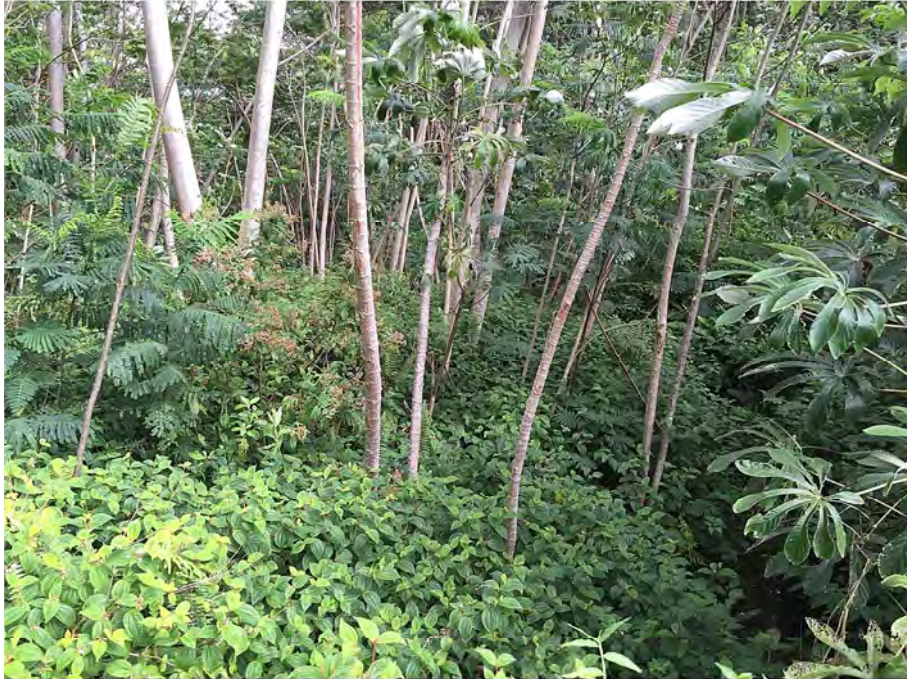
Kaloko (208).JPG

- ☒ l. Tree(s) were observed on the dam embankment. Trees have been identified as the probable cause of piping failures, and can possibly cause severe damage to the embankment if they are uprooted during a high winds. Corrective action is required to remove the tree hazards from the dam. All repair work shall be accomplished as per the requirements of licensed geotechnical or civil engineer. Routinely monitor the damaged area for signs of settlement and seepage.

Kalako Reservoir (KA-0030)  
trees in breach

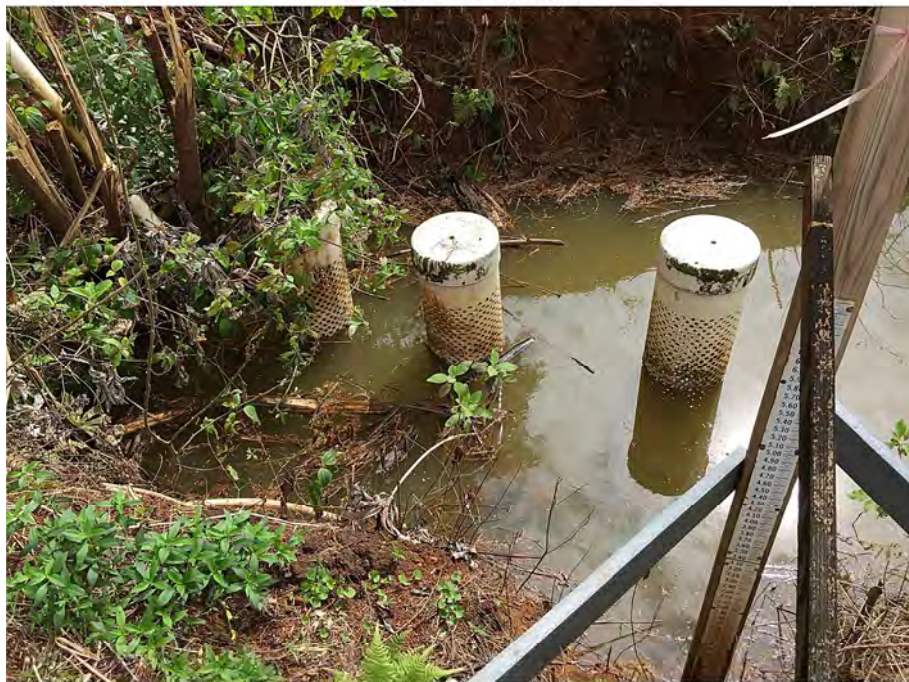
Kaloko (210).JPG

Kalako Reservoir (KA-0030)  
intake to outlet works

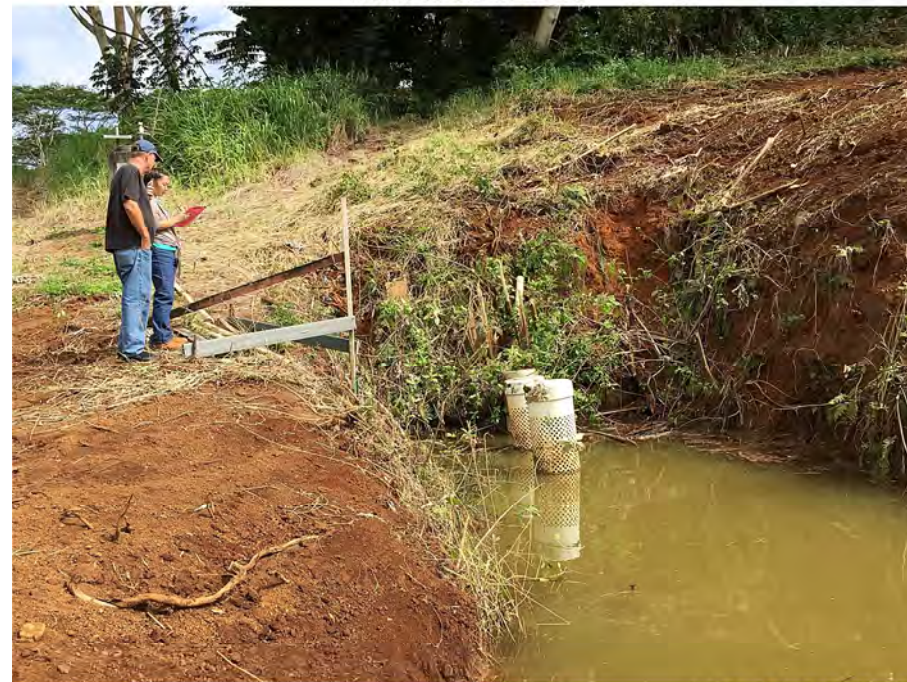
Kaloko (211).JPG

Kalako Reservoir (KA-0030)  
intake to outlet works

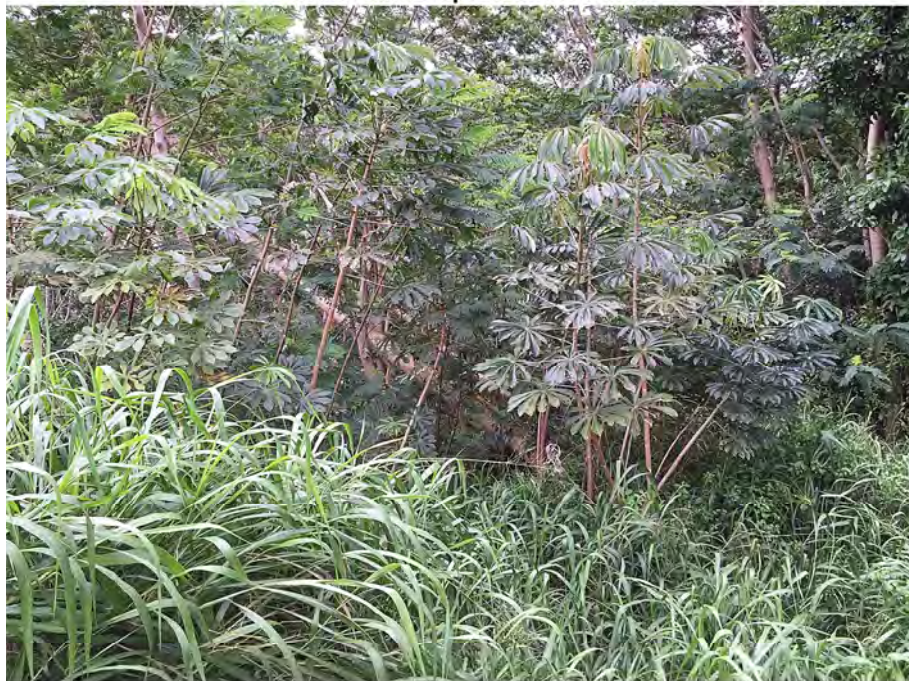
Kaloko (212).JPG

Kalako Reservoir (KA-0030)  
downstream slope to outlet works

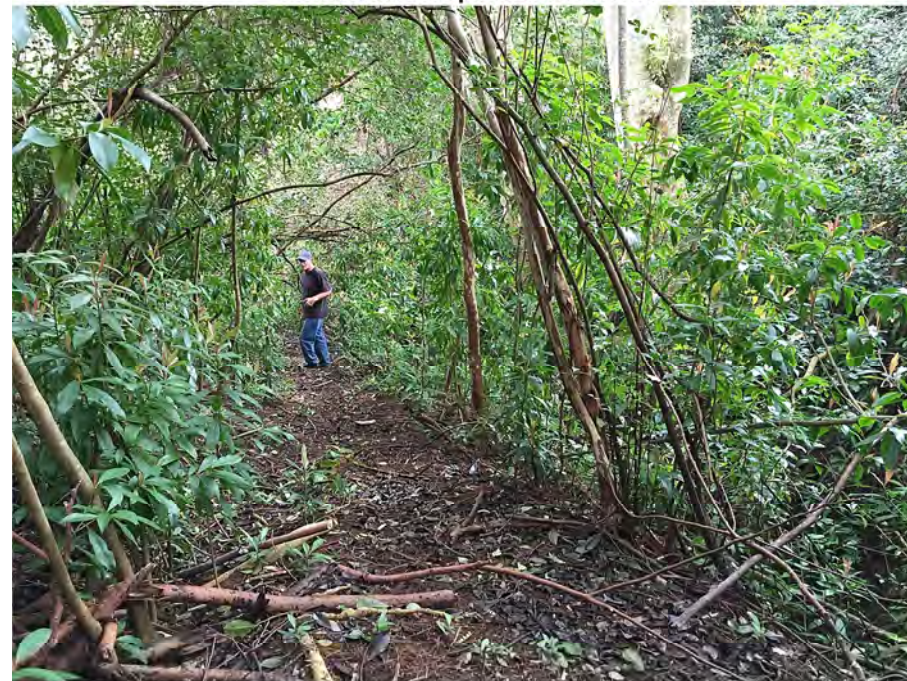
Kaloko (213).JPG

Kalako Reservoir (KA-0030)  
downstream slope to outlet works

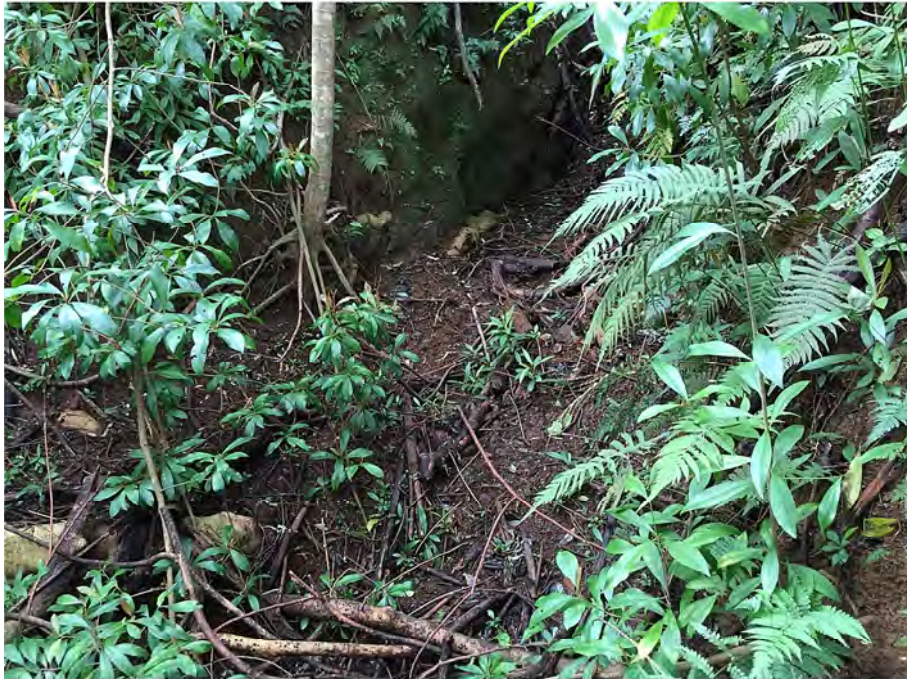
Kaloko (214).JPG

Kalako Reservoir (KA-0030)  
outlet tunnel

- ☒ l. Verify operational condition of all valves. Confirm that the drain valve is functional.
- ☒ m. Investigate and document condition of tunnel entrance from puka pipes. Vault reported to have been grouted – unknown valve condition/status and needs to be evaluated

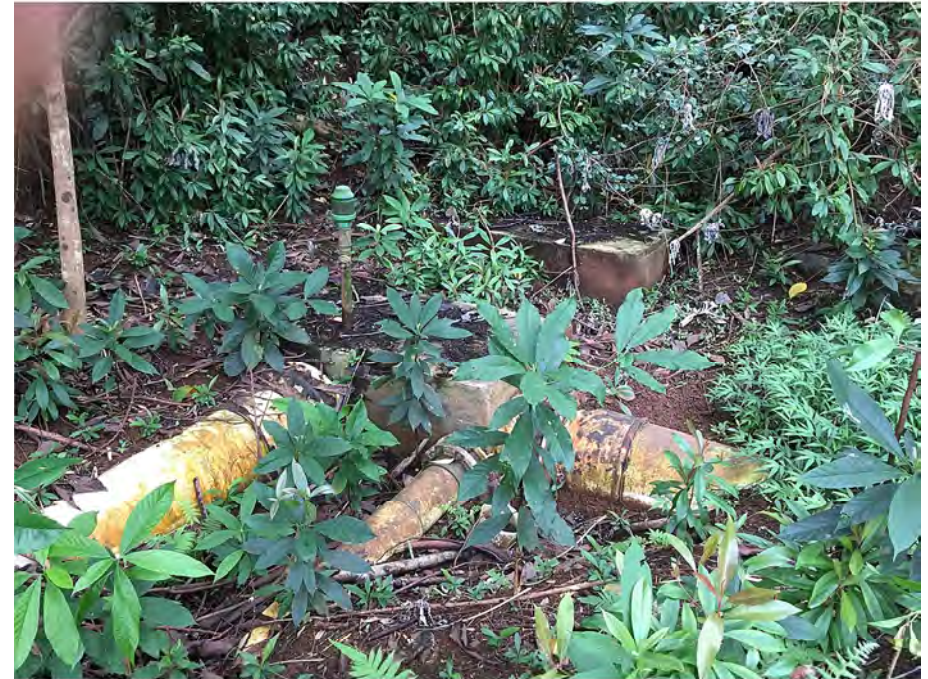
Kaloko (215).JPG

Kalako Reservoir (KA-0030)  
downstream outlet valves

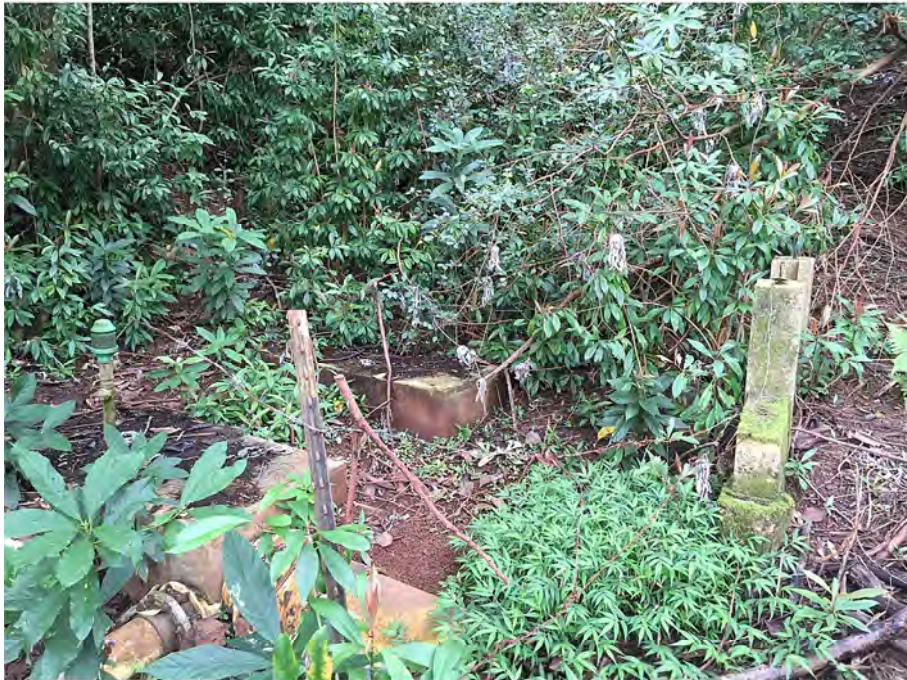
Kaloko (216).JPG

Kalako Reservoir (KA-0030)  
downstream outlet valves

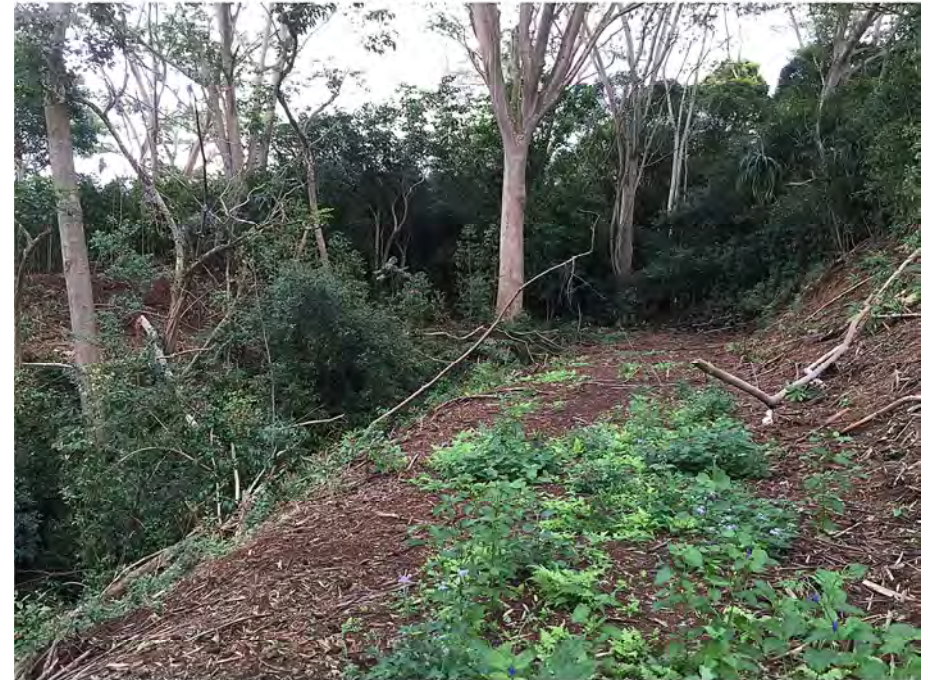
Kaloko (217).JPG

Kalako Reservoir (KA-0030)  
downstream access road to outlet

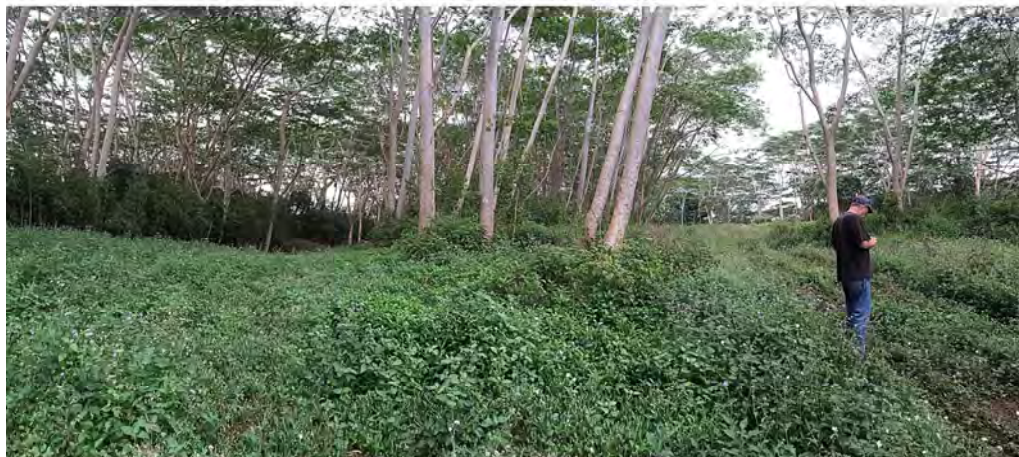
Kaloko (218).JPG

Kalako Reservoir (KA-0030)  
view from embankment

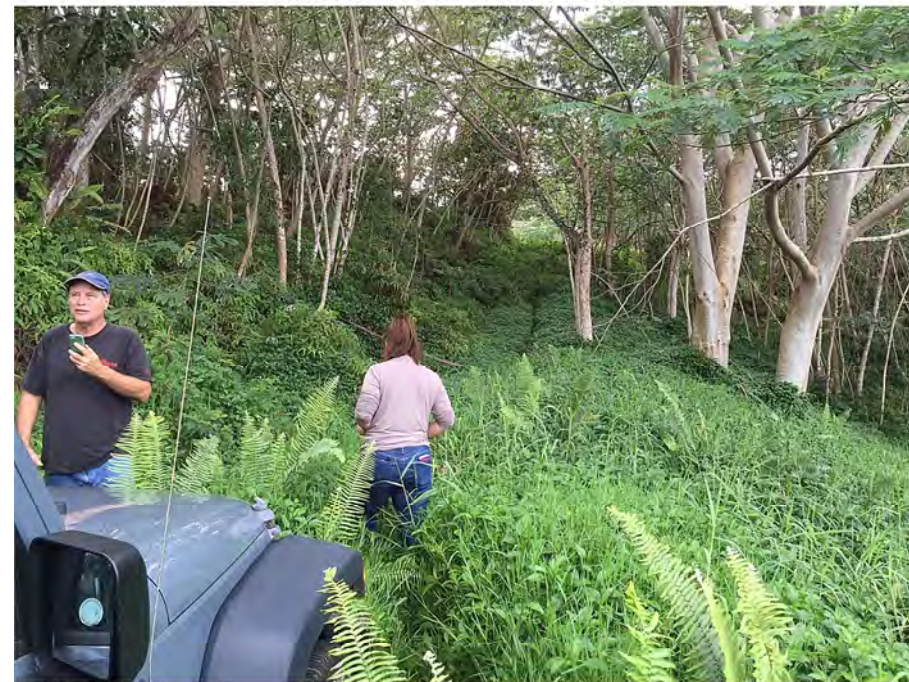
Kaloko (219).JPG

Kalako Reservoir (KA-0030)  
access road to Moloaa diversion

**Access to the Kaloko Ditch throwaways needs to be continually maintained so that operations can reach them to control flows during inclement weather conditions.**

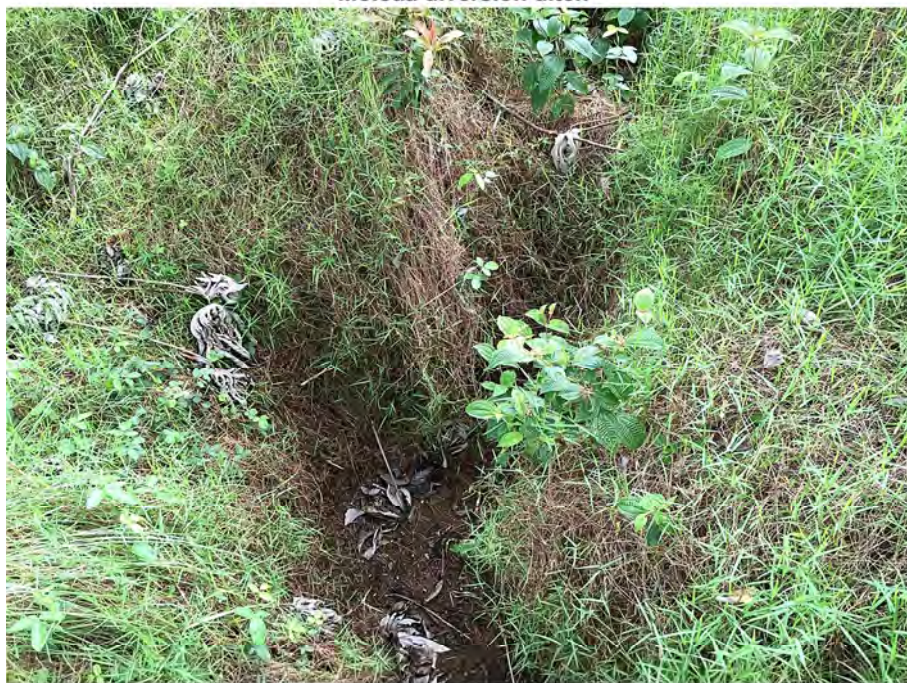
Kaloko (220).JPG

Kalako Reservoir (KA-0030)  
Moloaa diversion ditch

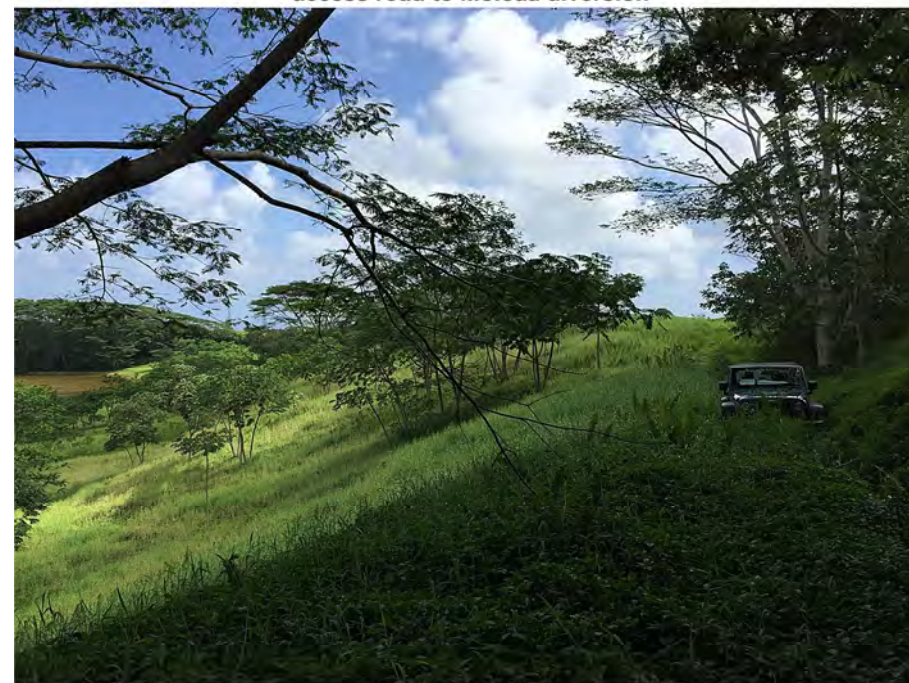
Kaloko (221).JPG

Kalako Reservoir (KA-0030)  
access road to Moloaa diversion

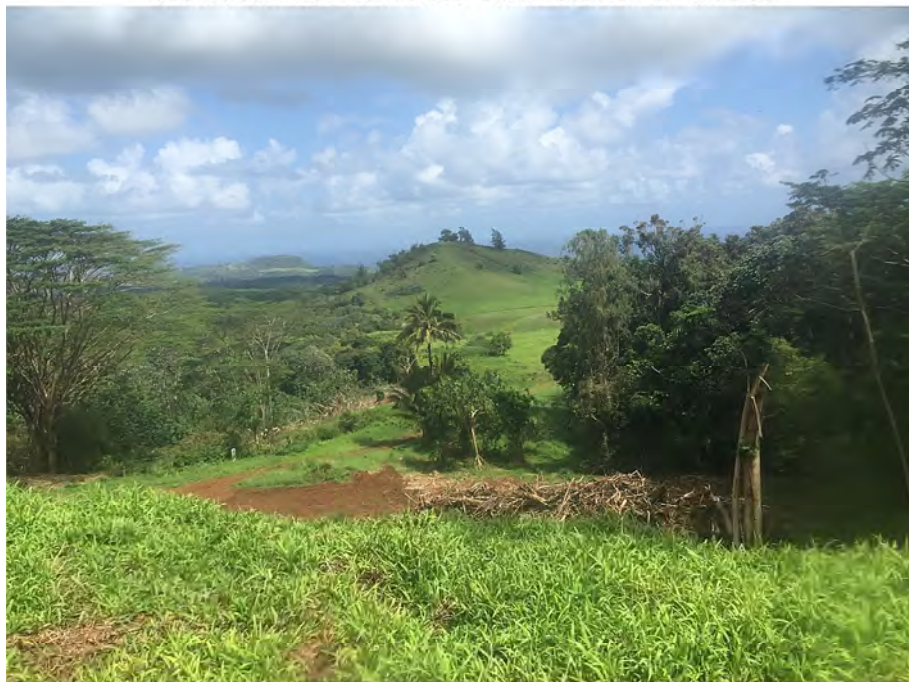
**Kalako Reservoir (KA-0030)**  
dosnstream view from crest - small reservoir on left side

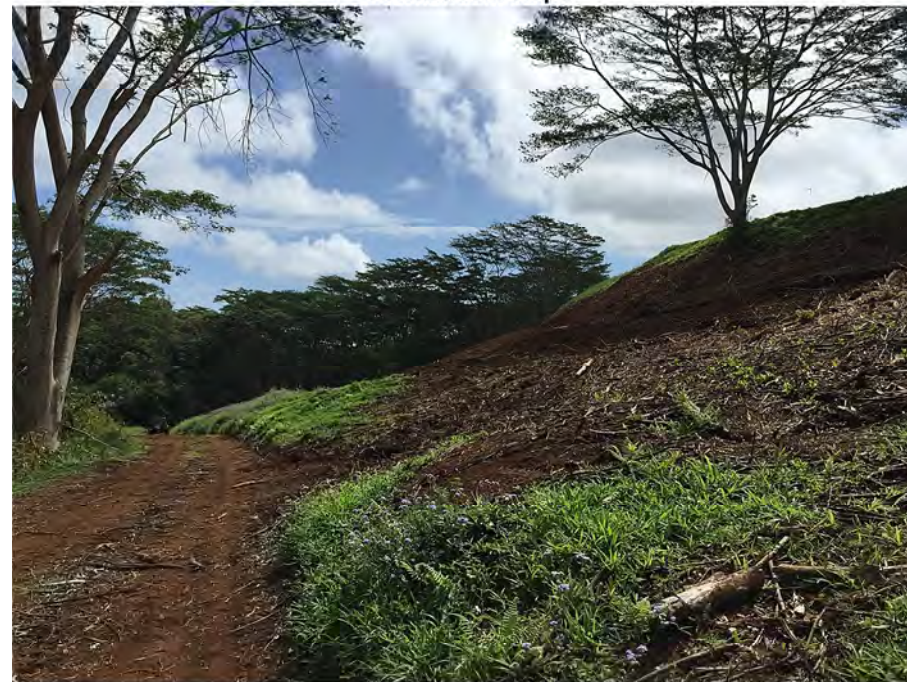
**Kalako Reservoir (KA-0030)**  
downstream slope

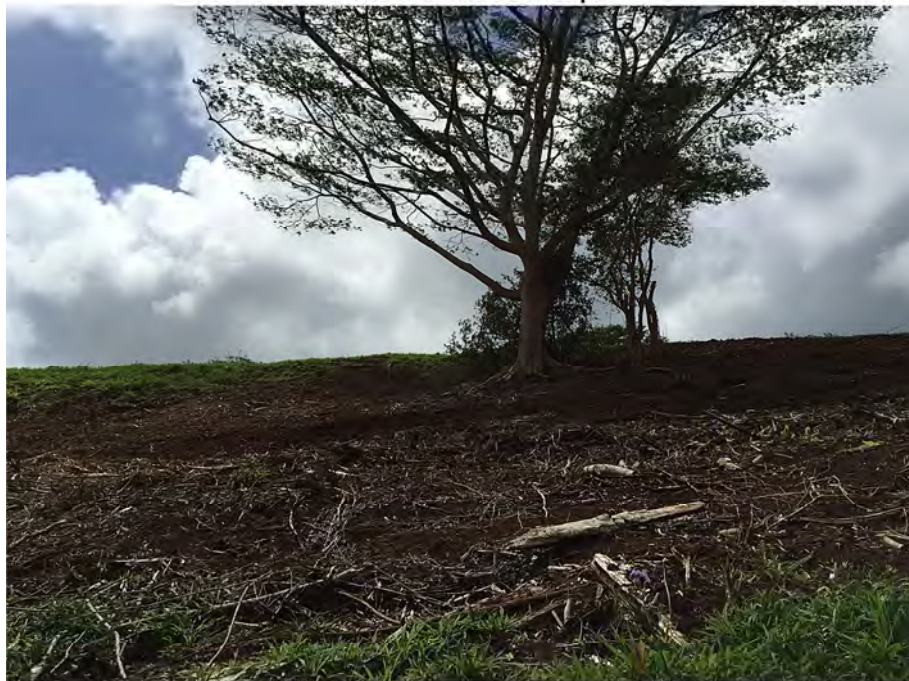
**Kalako Reservoir (KA-0030)**  
tree on downstream slope

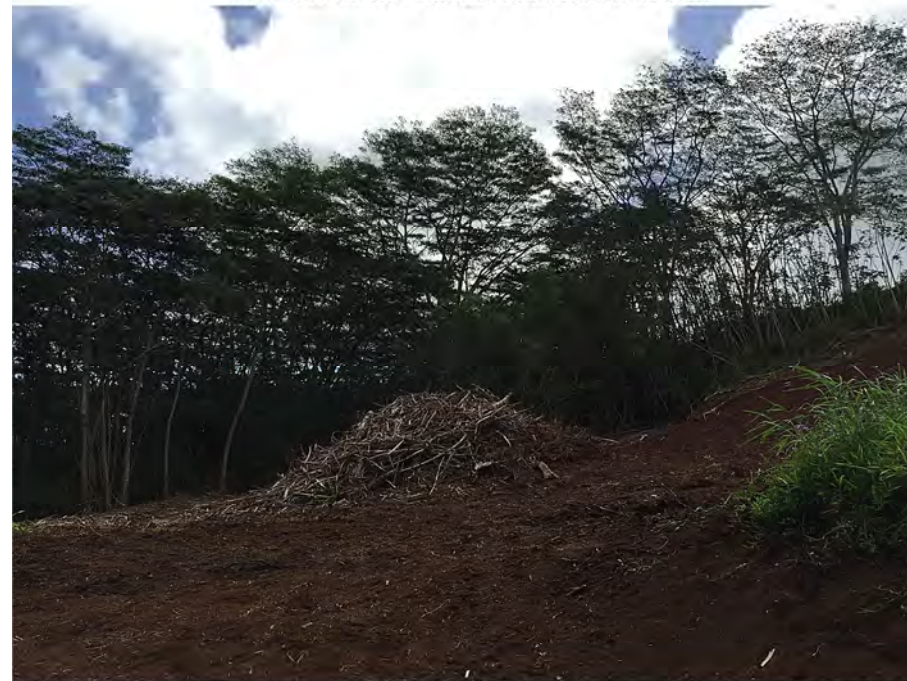
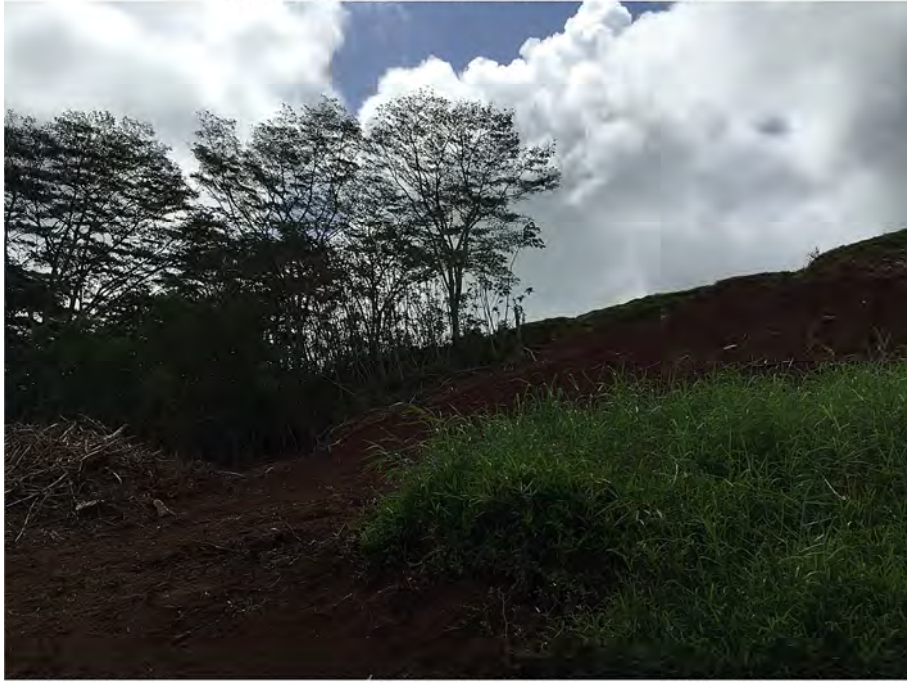
**Kalako Reservoir (KA-0030)**  
downstream toe - debris removed from dam

Kalako Reservoir (KA-0030)  
downstream toe - debris removed from dam

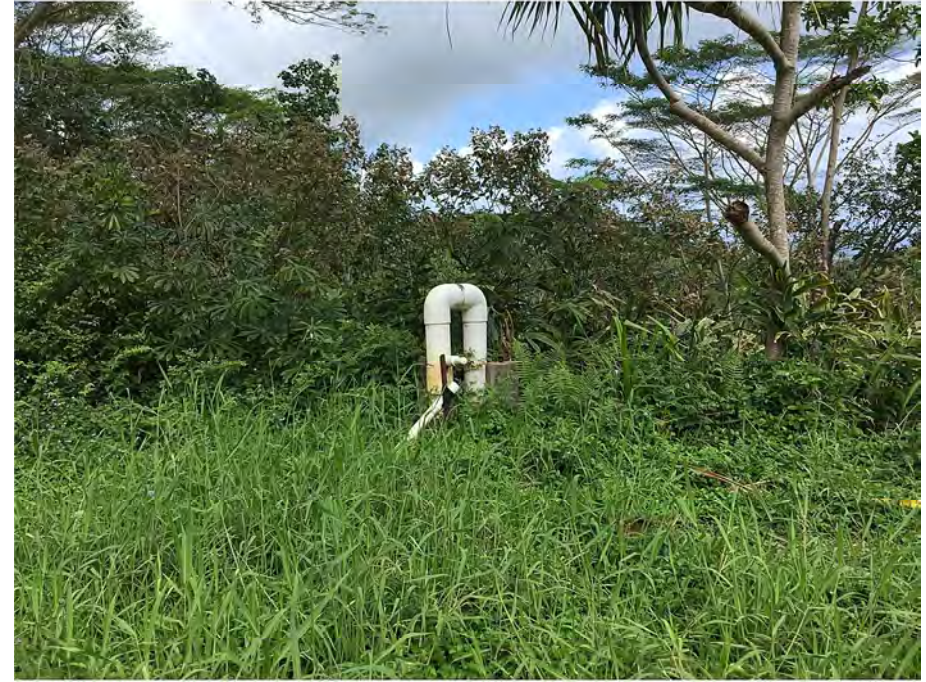
Kaloko (228).JPG

Kalako Reservoir (KA-0030)  
piping on downstream slope
